Smoke and Dye Testing Summary

High Level Sewershed

Test ID	Test Type	Date Inspected	Company / Super.	Blower MH	Ground Condition	Notification Made?	Total Length
S1028-252	Smoke	8/27/2009	ADS/TM	S21QQ_001MH	Dry	Yes	771.23

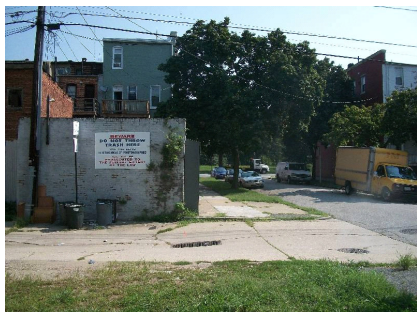
Picture \S1028-252-OB01-P01.jpg

Source Catch Basin

Location Alley

Comments Smoke from catch basin in alley behind 3200 Auchentoroly Terr.

Comments Back of house, 3200 Auchentoroly Terr.

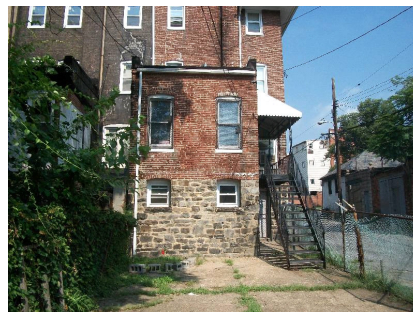
Picture \S1028-252-OB02-P01.jpg

Source Cleanout

Location Yard - back

Comments Smoke from cleanout in back yard. 1603 Gwynns Falls Pkwy.

Comments Back of house, 1603 Gwynns Falls Pkwy.
